PROJECT NO. 1470472-1
SUBJECT: Operational Suitability Test of
the DR-37A Airway

HEADQUARTERS
AIR PROVING GROUND COMMAND
Eglin Air Force Base, Florida

INTERIM REPORT
ON THE
OPERATIONAL SUITABILITY TEST OF THE
RP-57A AIRCRAFT

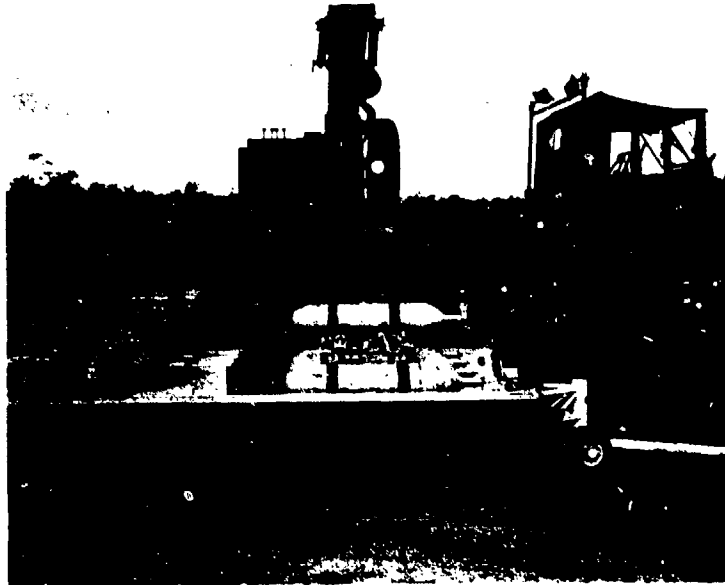
PHOTO 5

Side view showing proper position of door and crane. Note the positioning of the crane mount to provide proper alignment of the bomb during the sway-bracing operation.

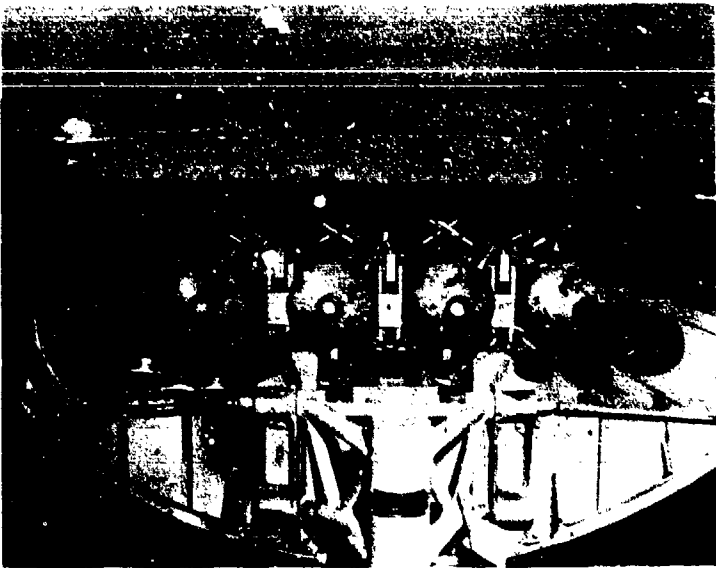
PHOTO 6

Front view of bottom four M-120 Bombs with sway braces fully tightened.

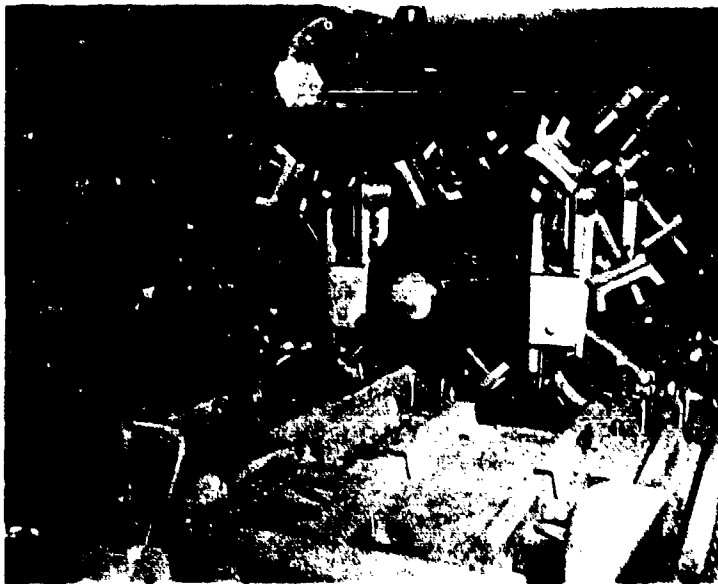
PHOTO 14

Another view of M30 GP Bomb installation in forward bay.

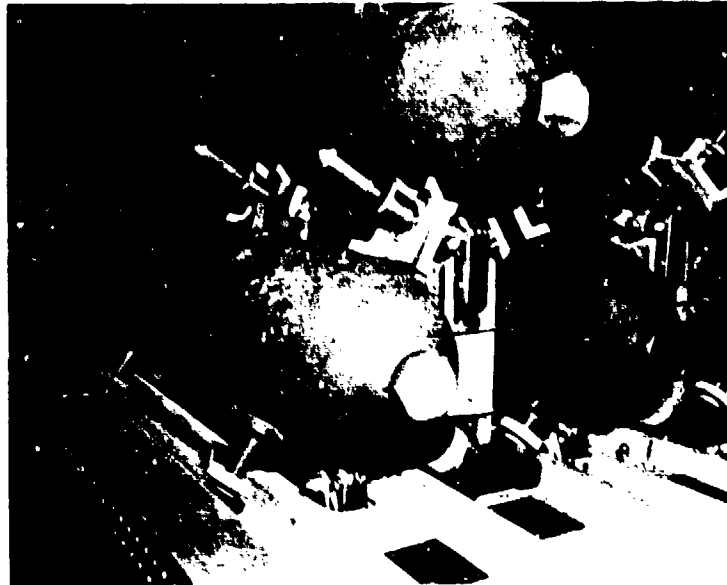
PHOTO 15

M30 GP Bomb properly installed
in center bay. Center and rear
bay installations of this bomb
are satisfactory.

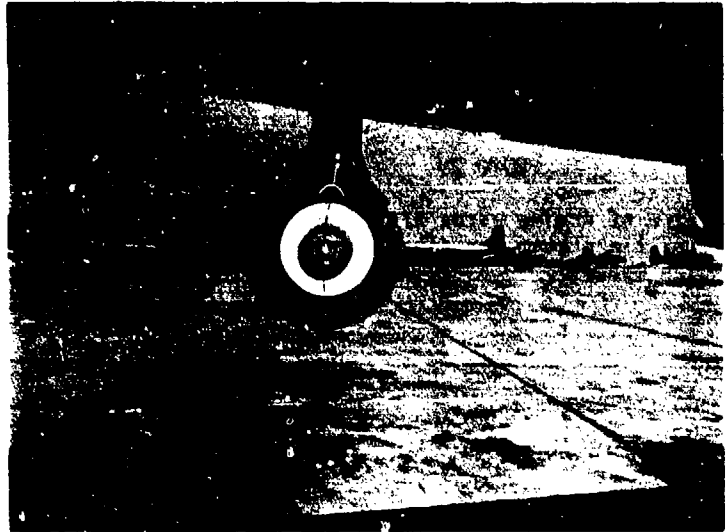
PHOTO 28

a. Eight sorties were flown exposing a full load of M-120 Photoflash Bombs and inert fuzes to the slip stream for five minutes at the following airspeeds: 250, 325, 400, and 434 knots. The results indicated that arming wires of front bombs were bent when exposed at airspeeds of 400 knots and above. The reason for this condition was not determined. It was concluded that it was caused by either slip stream or by interference by improper stowage of the bomb bay door electric cable installation (PN 272-708002) during rotation of door. (See Photos 31, 32, 33, and 34.) Appropriate photos are included to show the amount of bending to the arming wire, and illustrations of cable stowage mentioned above. (See Photos 28, 29, and 30.)

M-120 Bombs, fuzes and arming wires after exposure in slip stream for five minutes at 250 knots.

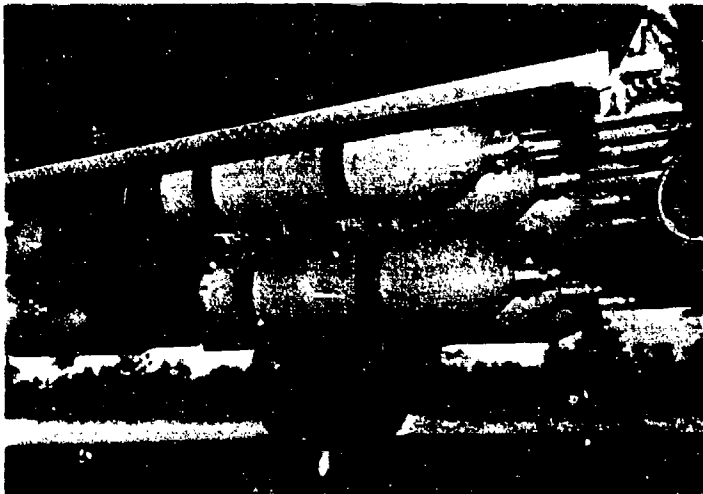
PHOTO 29

View of arming wires after exposure
in slip stream for five minutes at
325 knots.

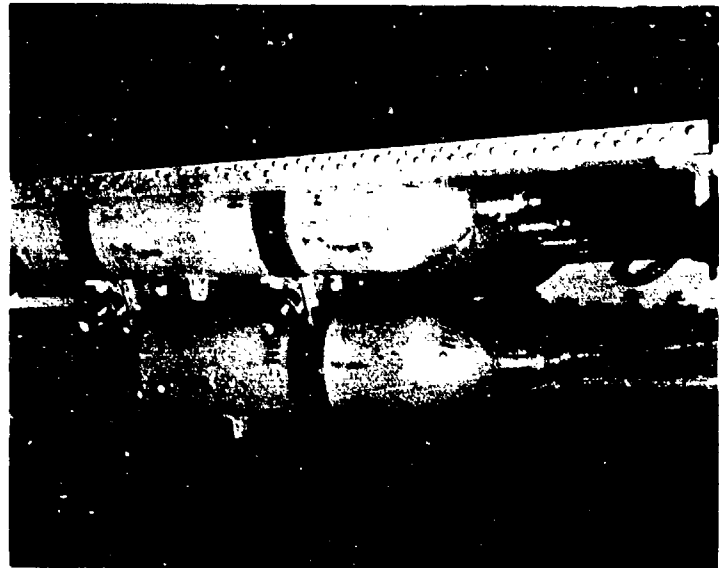
PHOTO 30

View of arming wires after ex-
posure in slip stream for five
minutes at 400 knots.
